# REPORT & VALUATION UPON:

9 SINCLAIR COURT SHEPHERD ROAD ST ANNES ON SEA LANCASHIRE FY8 3SR

### **DUXBURYS BENSTEAD LIMITED**

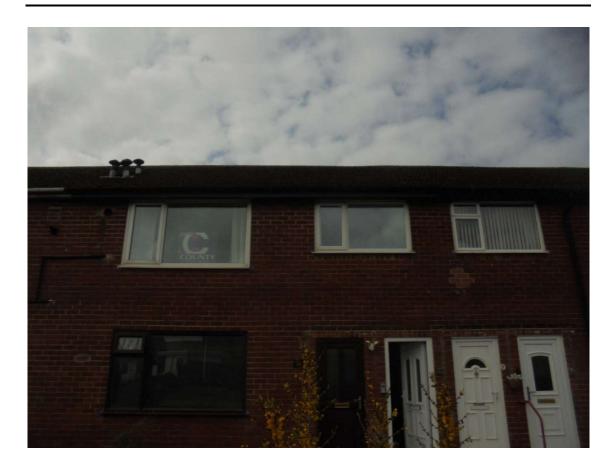
## **FRONT ELEVATION**

There is moss growth to the front pitch of the roof that ideally should be removed.

Masonry to elevations is unaffected by any serious structural movement. There is weathering of pointing to the front elevation which may necessitate some re-pointing attention in the medium term.

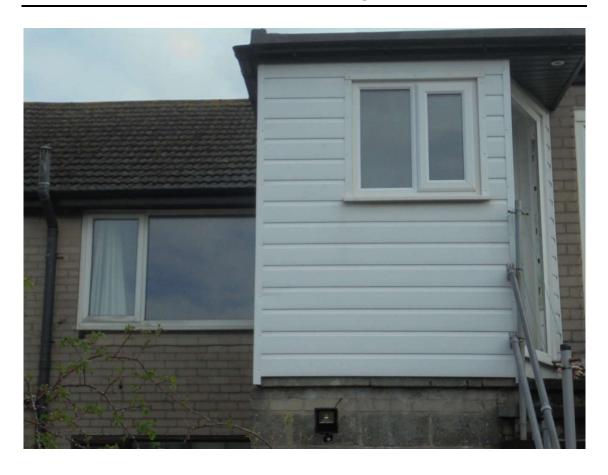
## **REAR ELEVATION**

The rear single storey kitchen projection is overlaid with a flat mineralised felt roof covering, currently watertight but inevitably of limited life expectancy.

The rear utility porch is overlaid with a fibreglass roof covering that would appear to have been applied within recent years. The structure is of rather more basic quality formation being, it would appear, timber framed and plastic clad both internally and externally.

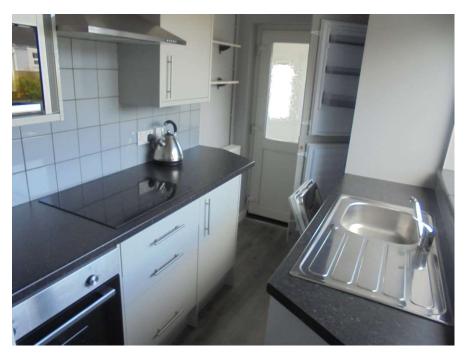
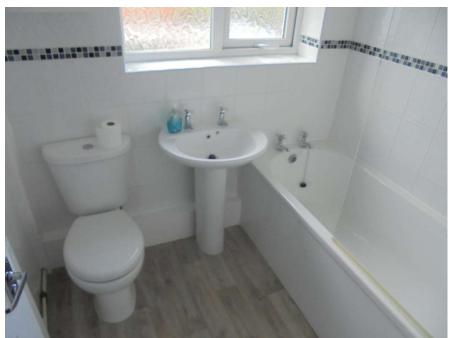
## KITCHEN AND BATHROOM

There are reasonable quality and relatively modern kitchen and sanitary fittings.
